Fire Investigation Report

The Glasgow School of Art

15 June 2018

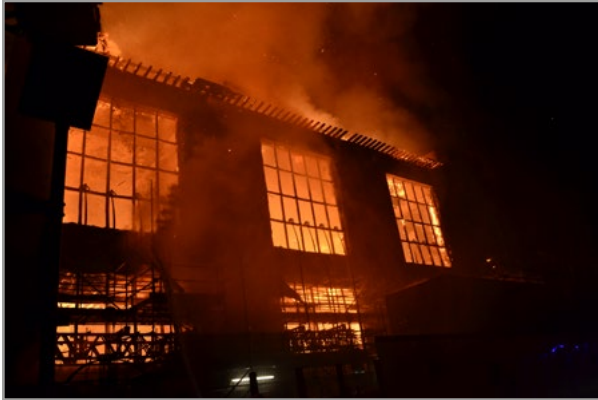
Figure 5 – Northeast corner

The Fire Investigation Unit from Yorkhill attended at 23:50hrs and observed a very well-developed fire visible through openings at most levels involving the east side of the building (Figure 5 above).

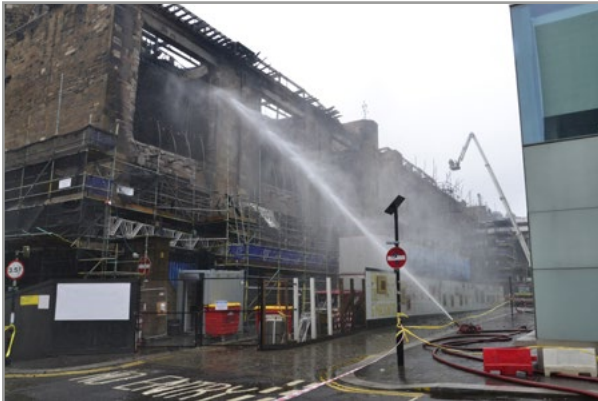
North Elevation, east end
Dalhousie Street/Renfrew Street corner

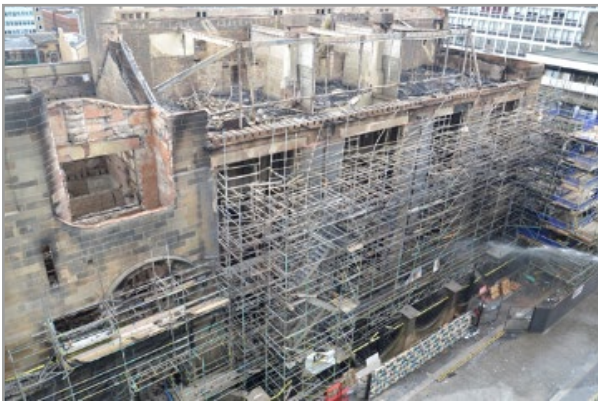
North Elevation, west end
Renfrew Street Scott Street corner

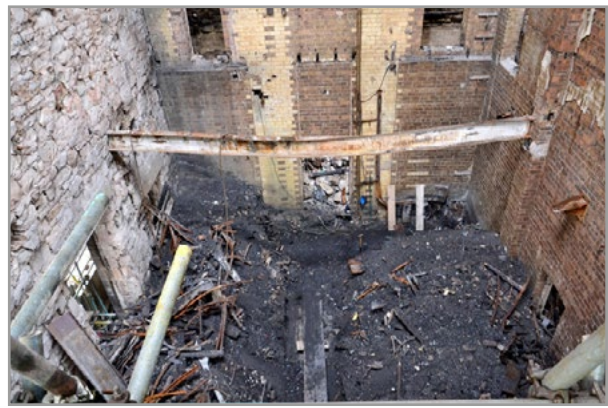
Figure 10 – Main contractor office level 2

This area was the route to the first "area of interest" to be excavated as part of Phase 1 excavation work. On the 15th October 2018, work commenced to create a safe forensic path through the main contractor office on level 2 towards the security guards' desk area. The excavation was limited to creating a safe 1-metre-wide passageway with minimum excavation towards the known location of the desk, with the objective to recover the FWS control panel and the CCTV hard drive (Figure 10).

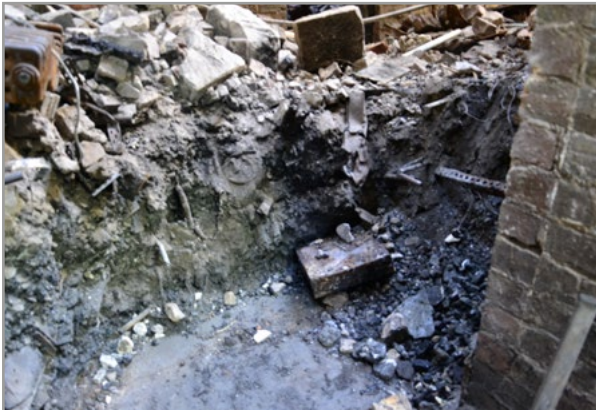
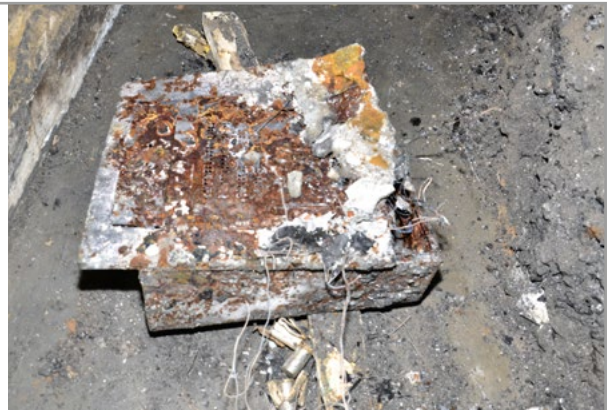
Figure 12 – FWS recovered

At 14:45hrs, the external housing of the FWS control panel was located below approximately one and a half metres of fire debris behind the location of the remains of the desk. The housing was located adjacent to the right-hand side of the corridor wall when facing west and 3 metres from the doorway leading to the main contractor office (Figure 12).

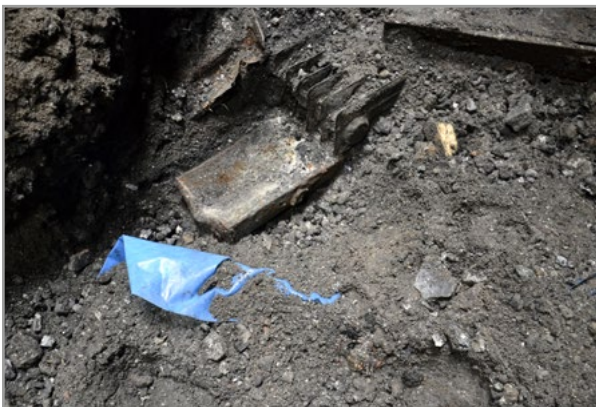
Figure 13 – Location and condition of CCTV Hard drive

On 5th November 2018 at 14:47hrs, the exterior metal housing of the CCTV hard drive (measuring about 300mm x 300mm x 60mm) was located and observed to have suffered severe fire and heat damage. The housing was photographed prior to being removed and impounded at 16:30hrs and sent for forensic data retrieval (Figure 13).

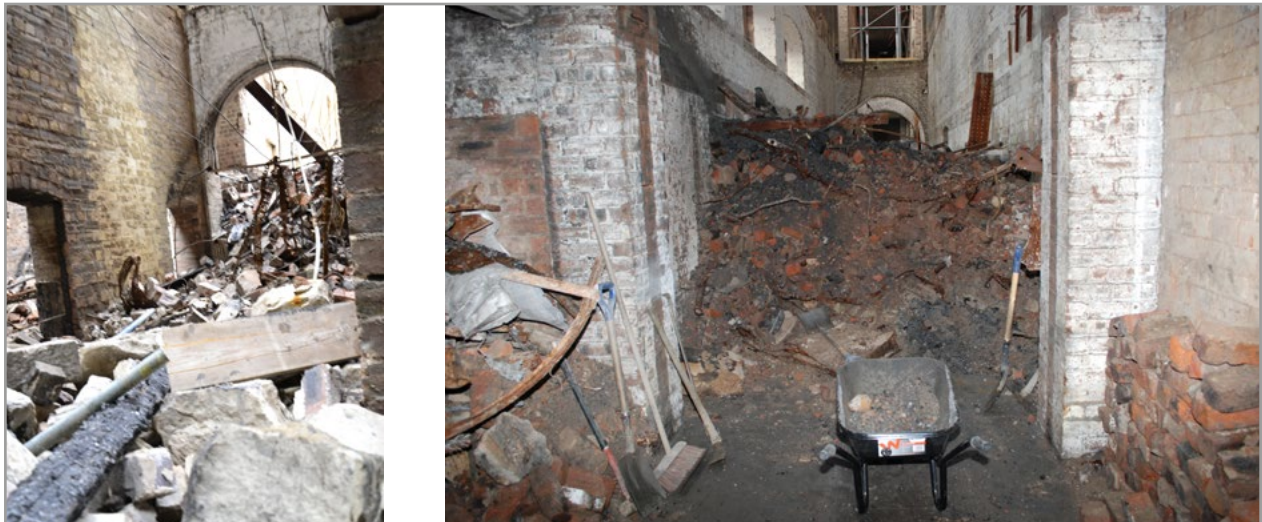
Figure 15 – Central Corridor level 2

Large quantities (several hundred tons) of fire debris were observed in the remains of both areas. Significant time, effort and resourcefulness was required to create safe systems of work to ensure safe access for FIOs (Figure 15 below).

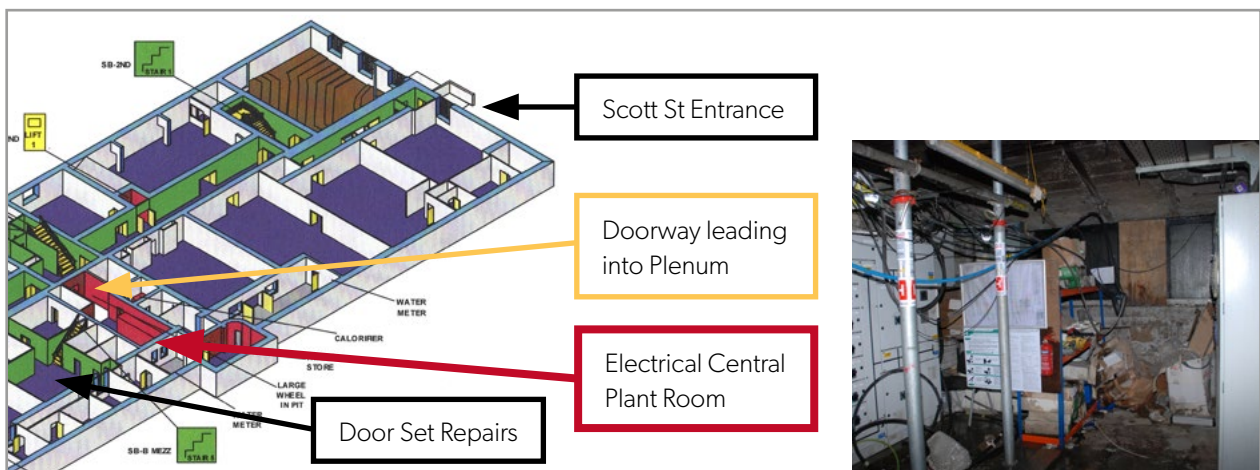
Figure 17 – Level 2 location (and photograph) of Electrical Central Plant Room

An energised three-phase distribution board was located to the righthand side of the new equipment. The three-phase lift supply, the supply to the temporary distribution board located in the plenum below level 2 (which supplied the temporary site electrical system) and the mains powered office supply originated from here. There was no evidence to suggest that the electrical equipment in this area should be considered as a possible origin or cause, due to no fire damage being observed or noted.

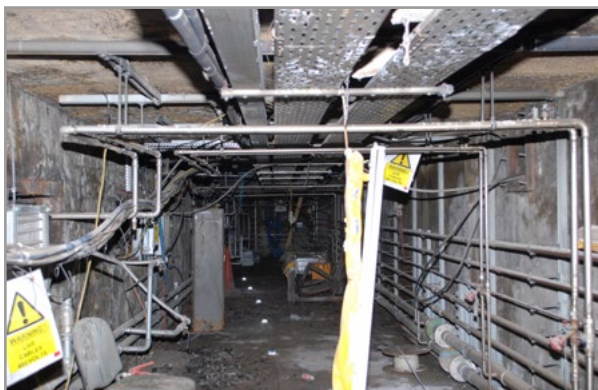
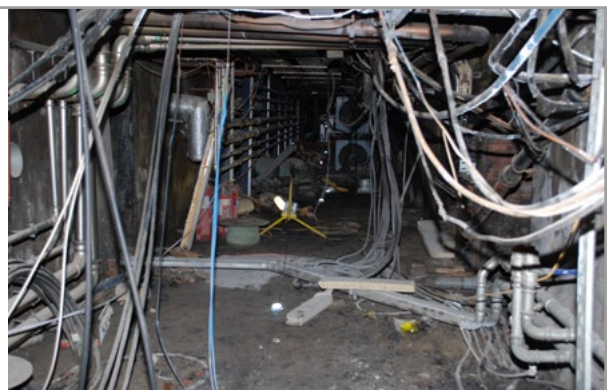
It was observed that the plenum had been utilised to route most of the electro-mechanical services for the building, including air conditioning ducts and fans, and a vast array of electrical and data wiring. Most of the wiring was observed to be secured to metal trays fastened at ceiling level. The majority of the plenum appeared to be undamaged by fire, with fire damage noted adjacent to vertical ducts which ran from numerous locations along the length of the plenum (Figure 18).

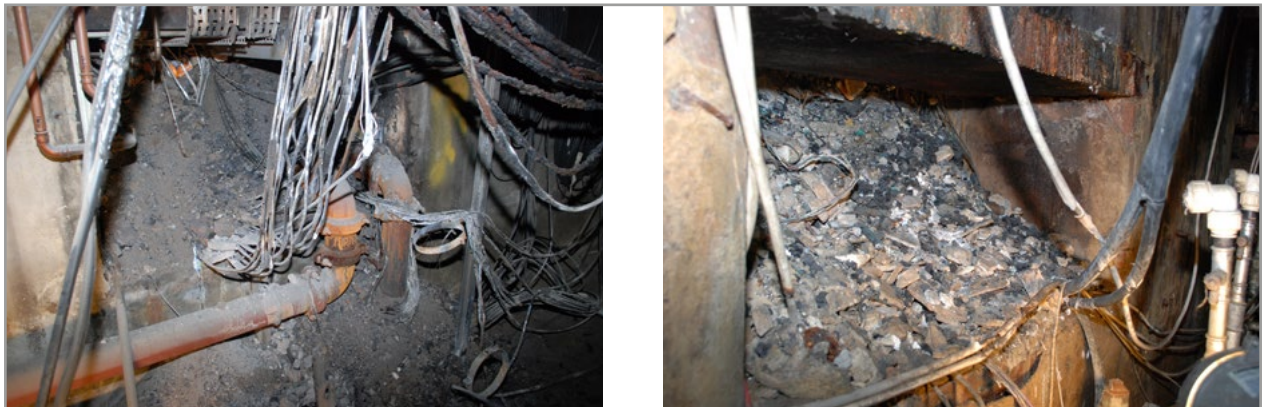
The remainder of the vertical ducts located on the north wall and to the left of the plenum entry point (leading East), were excavated from the 4th to the 7th December 2019. The ducts were observed to contain general fire debris including bricks, mortar, wood ash and general fine dust. No large pieces of wood were observed or located within the ducts. Electrical cabling entering the ducts had sustained severe fire damage, with the remaining cable forming a tangled section within the fire debris located at the bottom of the duct (Figure 19).

Figure 19 – Cables exiting vertical ducts into level 2 Plenum

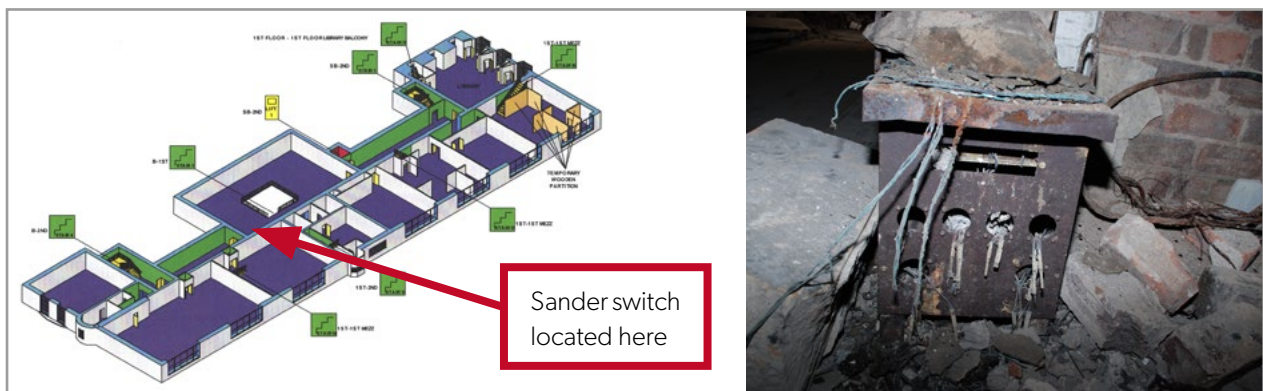
Several energised electrical supply cables were noted to be in use in a number of the vertical ducts. These supply cables served the lift, 110volt temporary site electrics and mains powered temporary site supplies. The mains powered cables supplied the contractors' offices located in the east of the building (levels 2 and 3), and an electrical control switch for a floor sander located on level 6 (Figure 20).

Figure 20 – Location of floor sander switch and the remains of one of nine 110volt site transformers

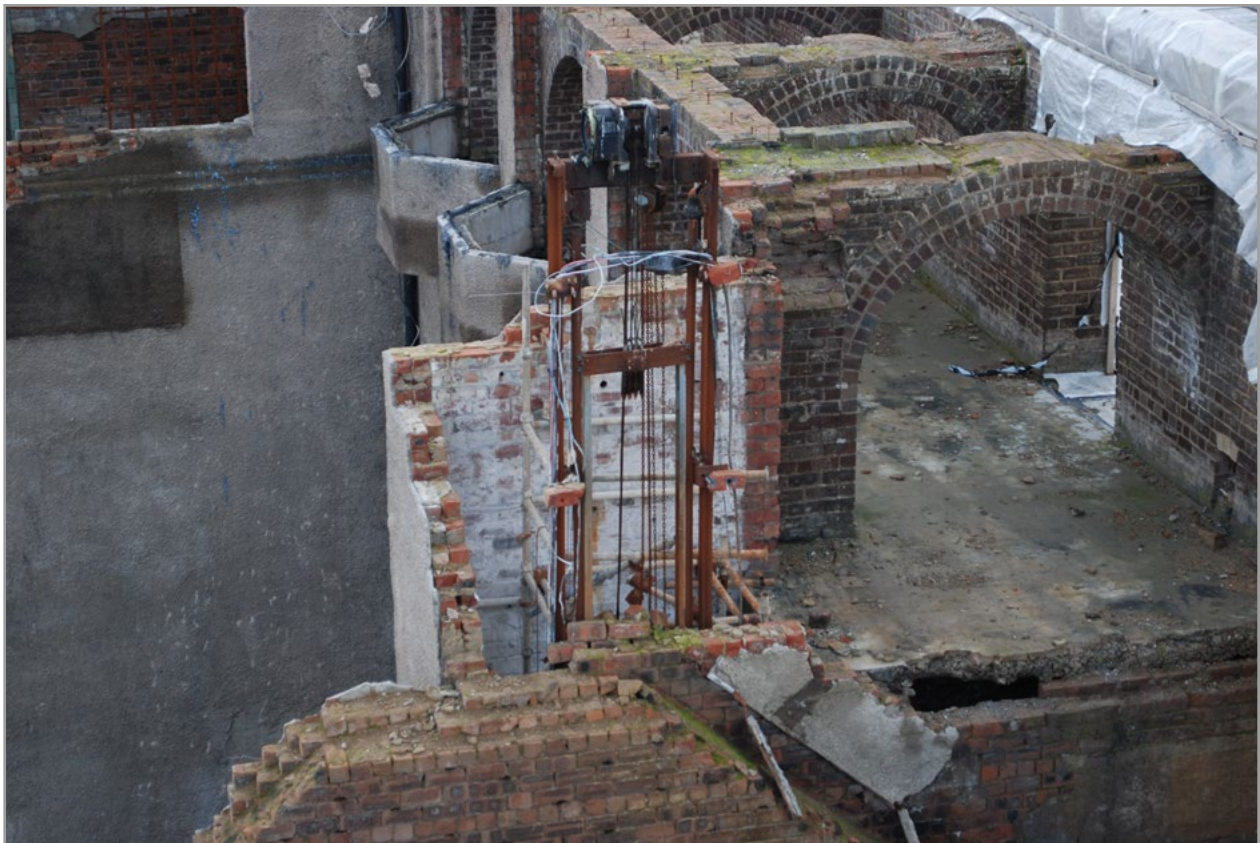
Figure 21 – Top of lift mechanism, west side

Due to the location of the lift shaft (midway along the west side of the building), both the wiring within the lift shaft and the supply cable termination at level 9 for the lift supply are not considered further as areas of origin or cause.

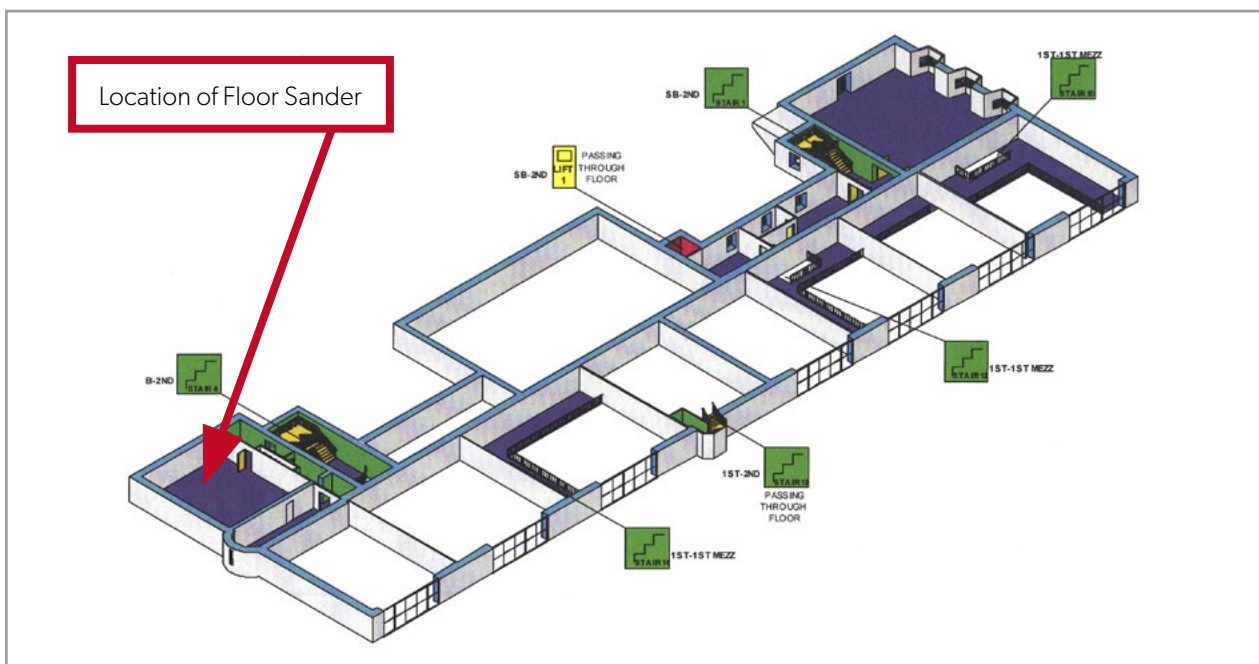
Figure 25 – Location of Floor Sander level 8, east side

3. Floor sanding was known to have taken place on the days leading up to the fire, at level 8 on the east side of the building at the location shown in Figure 25. Accidental ignition through chemical reaction inducing spontaneous combustion has been considered, as has electrical fault within the floor sander itself.
