Fire Investigation Report

The Glasgow School of Art

15 June 2018

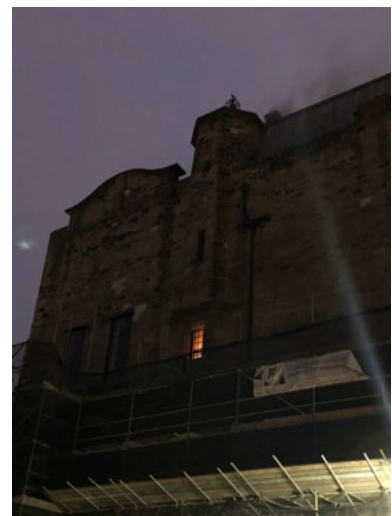
Figure 3 – Dalhousie Street east elevation

Around this timeframe (approximately 23:21hrs) a second member of the public, walking north up Dalhousie Street, observed a glow in a window aperture on the east elevation and took this photograph with a mobile telephone. In the photograph shown below in Figure 3, the glow of fire can be observed, as well as smoke issuing from the top of the building.

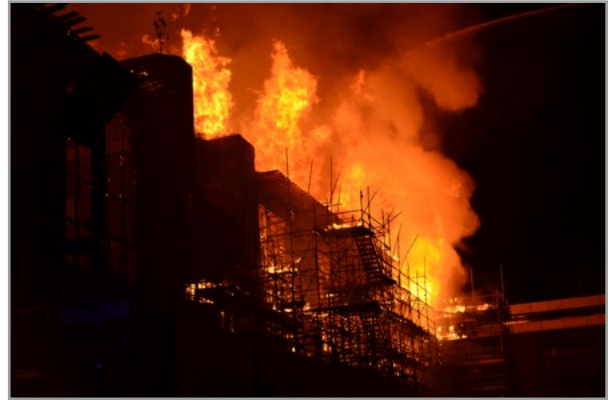
Figure 6 – Northwest corner

At 01:44hrs, DCO (**redacted**) assumed the role of IC. An “Informative” message was sent to JOC stating that PS were evacuating commercial properties on Sauchiehall Street and domestic properties on Dalhousie Street due to significant risk of collapse of the scaffolding enclosing the building and collapse of the Mackintosh Building itself (Figure 6 above).

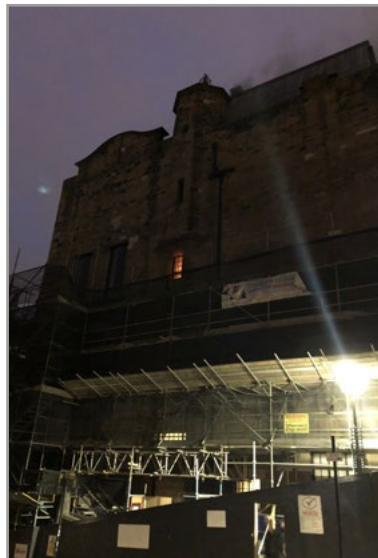
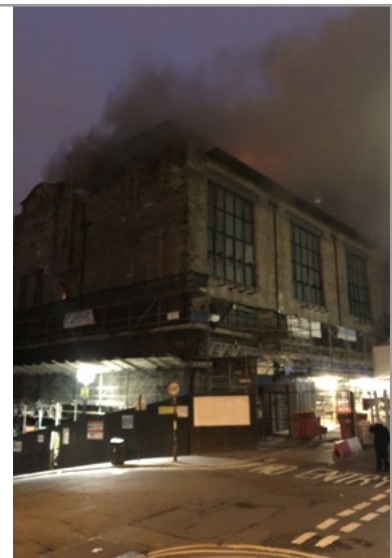
Figure 9 – Northeast Corner

The first SFRS crews are recorded on the CCTV footage arriving at 23:25hrs. A further photograph taken by a member of the public at approximately 23:25hrs captures fire venting from the roof at the east end of the building. This is shown in Figure 9 later in this report.

The initial area of fire is considered likely to have been on the east side on or above level 4. This is supported by the nightshift security guards' statement and by observations from SFRS crews who initially entered the building at level 4. The initial location of a developed fire above level 4 is also supported by photographic evidence in Figure 9 below, which shows a fire burning within a level 6 room, visible through a window opening on the east elevation. These two photographs were taken by a passer-by from street level at Dalhousie Street. This area of known fire is further supported by the initial SFRS ICs account where he witnessed fire venting from the roof high on the east side above Renfrew Street.

Photograph
taken at 23:21hrs

Photograph
taken at 23:25hrs

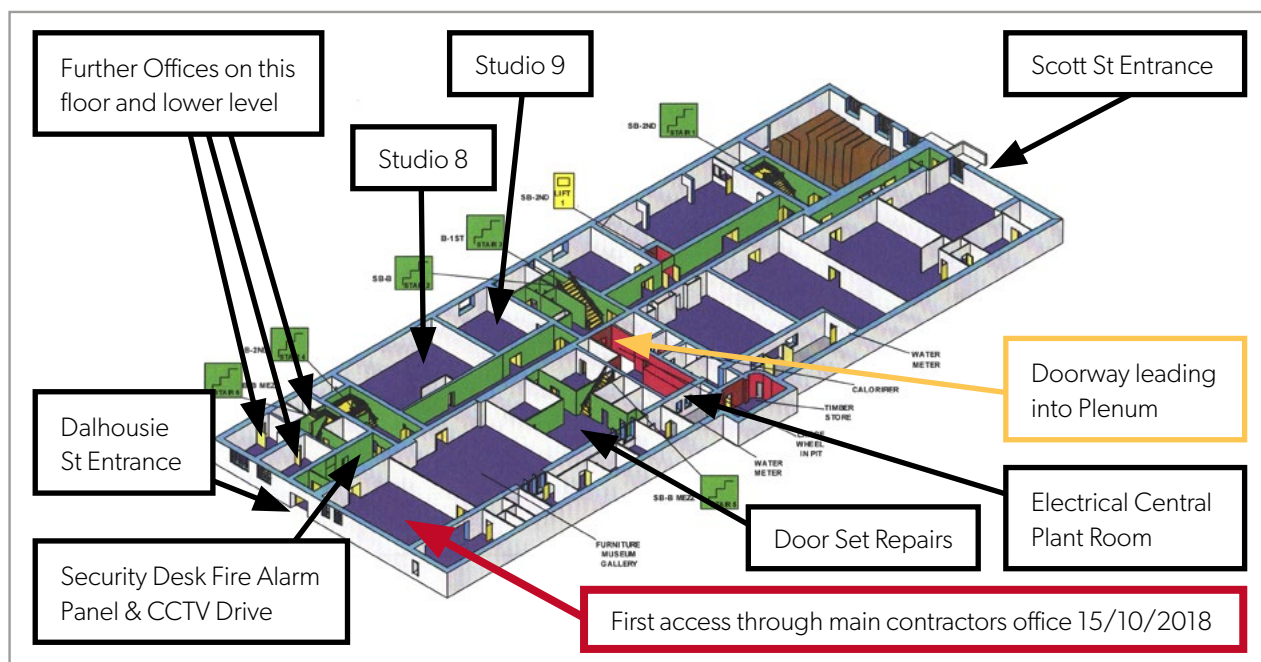
Figure 11 – Level 2

Entry into the corridor on level 2 at the east end of the building was achieved on the 30th October 2018 (Figure 11).

On the 1st November 2018, the excavation progressed into the level 2 corridor area (see Figure 11) where the severely damaged remains of the security guards' desk were uncovered at approximately 14:00hrs.

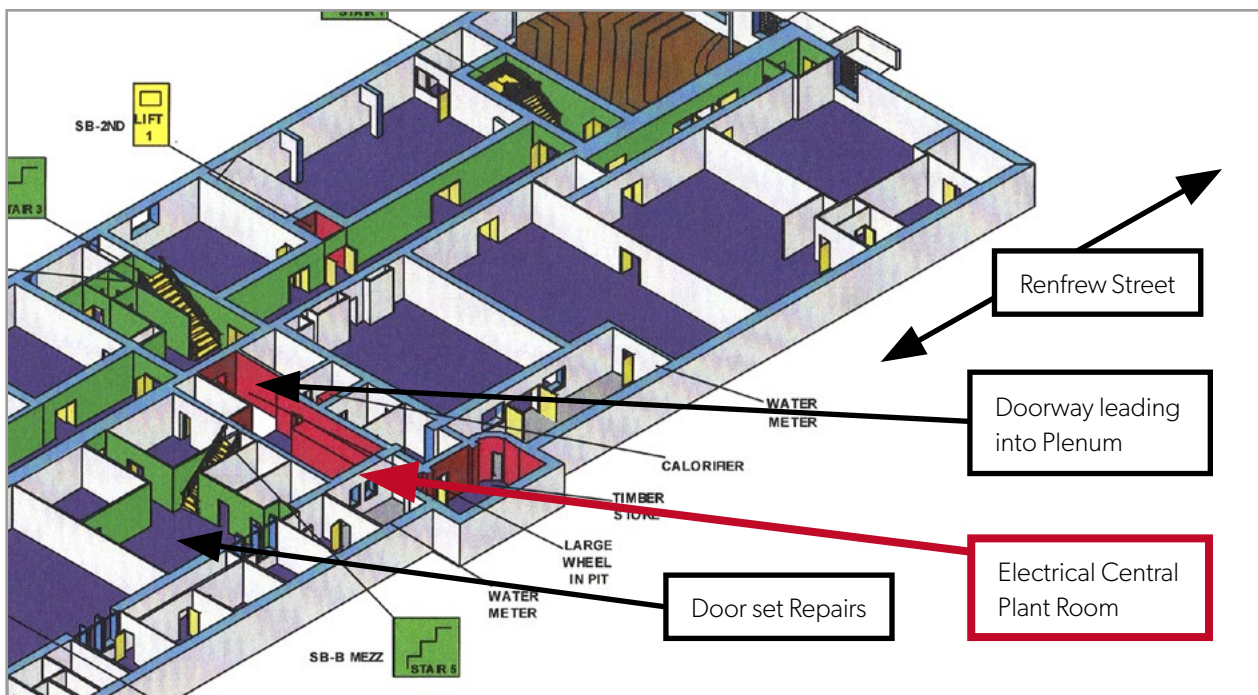
Figure 22 – Central plantroom level 2

The investigation considered seven theories that could support an electrical source as the cause of ignition.
